# Gårdsten Solar Buildings

- location:** Göteborg, Sweden
- dates:** originally built 1969-1972, renovated 1998-2004 in 2 phases
- type:** Sustainable renovation of existing 'million programme' prefabricated element and slab housing buildings

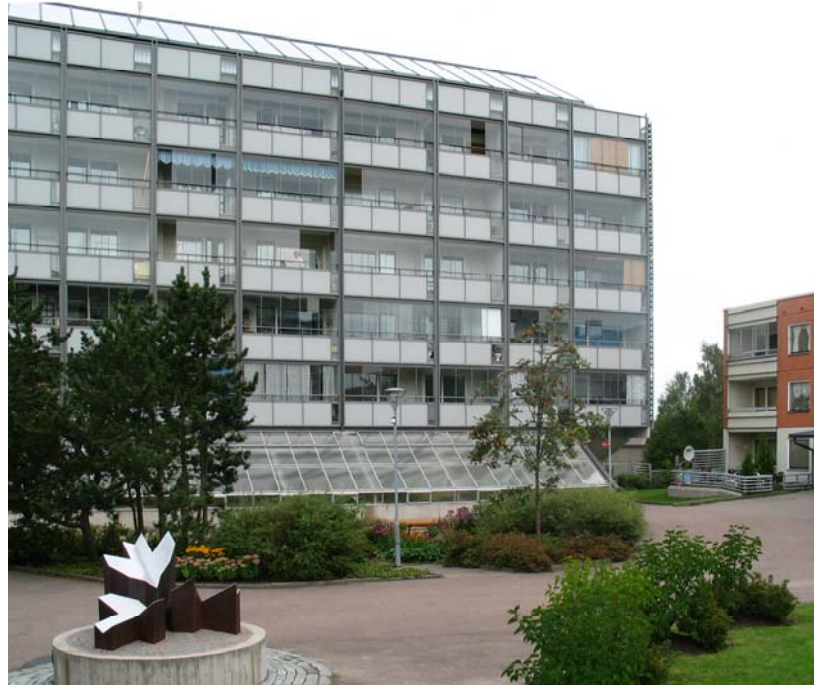
#### **Situation before renovation** *(on picture to the right)*

- Most of the roofs had problems with leaking of rain and snow which had to be repaired almost every year.
- Facades and structural elements of concrete had damages caused by corroding concrete reinforcements
- Plaster falling down
- Corrosion of metal details such as doors, door frames, balconies, etc.

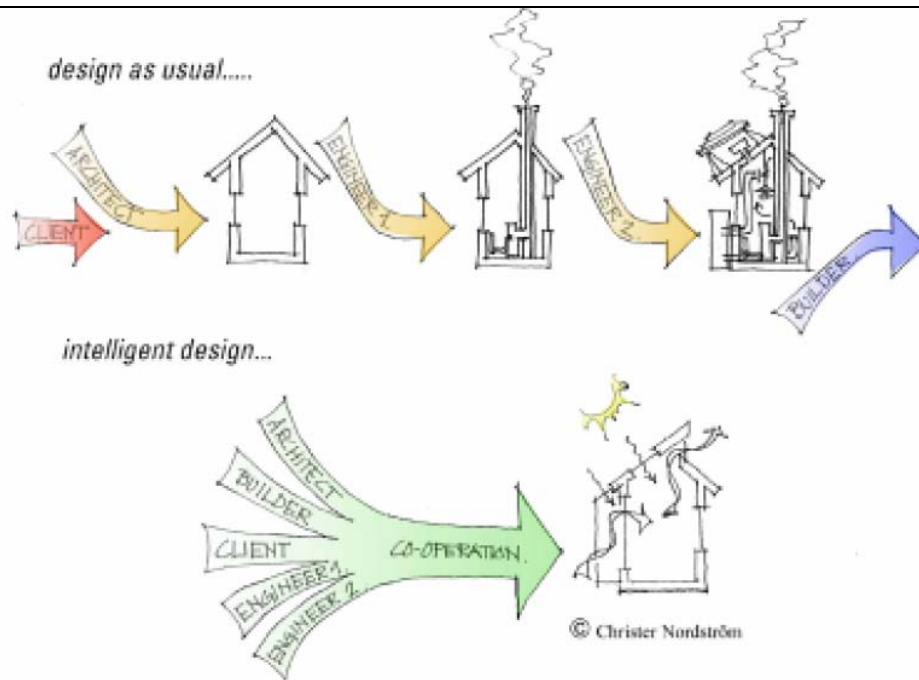
**Figur 1 Design process**

The success in the renovation is seen in the integrated design process shown on figure 1.
